## Trouble Shooting Guide

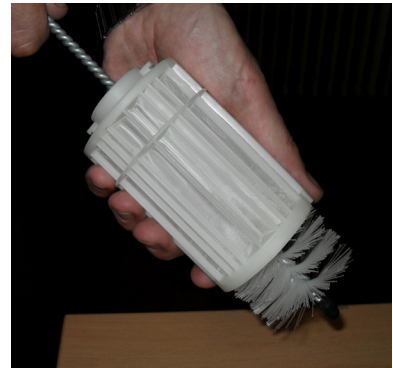
##### 1. Pre Filter is clogged

- Remove, clean thoroughly with G Filter brush provided. Ideally, have a spare Pre Filter so that the clogged one can be removed, allowed to dry and brushed thoroughly once dried.

Note – It may be necessary to change or clean the prefilter every day, especially when the filter has just been set up, or where the tank is heavily stocked, frozen food is fed, or where “foraging” species are kept.

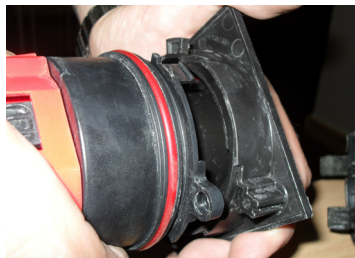
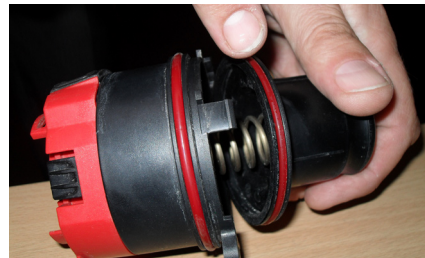
- Check to see if the primer button is sticking or stiff. If so, the primer needs to be cleaned, or the O ring needs to be re-positioned, or both. To do this, detach the pre-filter strainer and remove the two Phillips screws, pull apart the valve. The inner O ring and all the parts that are greasy should be washed in warm soapy water and rinsed thoroughly.

The O ring and the part that slides in and out can be lubricated with silicone lubricant or a very small amount of vegetable oil.

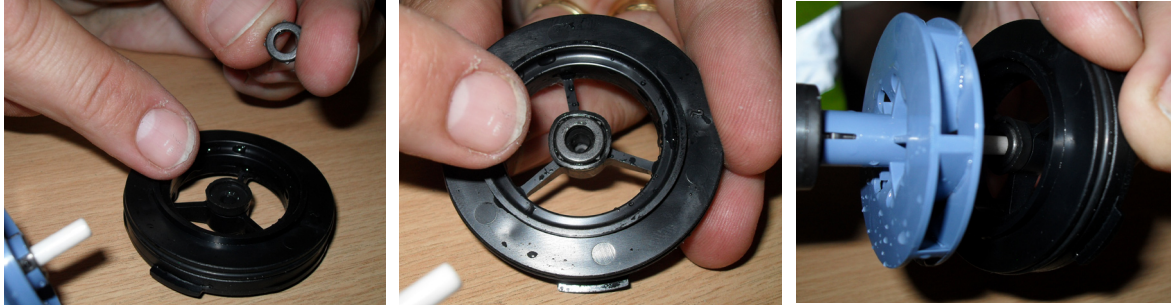
- Impeller may be clogged, worn or damaged. Remove, Inspect and clean as necessary. Clean the well in which the impeller sits. Ensure that the small ceramic washer that sits in the base of the impeller well is present and intact.

If the impeller is worn or damaged it may need to be replaced

Impeller for G6 Art# A20262

Impeller for G3 Art# A20260

- If the low flow persists and is accompanied by a low humming noise, then the impeller may need to be replaced- Impeller for G6 Art# A20262/ Impeller for G3 Art# A20260.
